Project: St Mary's Church, Portreath

Concrete Repairs

Main Contractor: SWCR Ltd

Date: June 2016

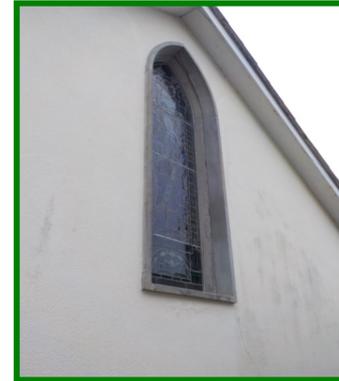
Several of the window surround have various degrees of cracking, spalling and bulging areas. Some of the windows also had rust staining and exposed corroded reinforcement. Several quite large lumps of the concrete had completely de-bonded and have started to fall off, causing a serious safety risk to church users below.

All the defective areas were broken out and all loose concrete were removed. All exposed reinforced steel was then cleaned and coated with Flexcrete Steel Reinforcement Protector 841 and Flexcrete Bonding Bridge 842. The treated areas were then repairs with a Flexcrete Monomix Concrete Repair mortar and a final re profiling and levelling coat of Flexcrete Monolevel 844 SP applied.
