Project: Plymouth Promenade

Client: Amey LG Ltd

Main Contractor: SWCR Ltd

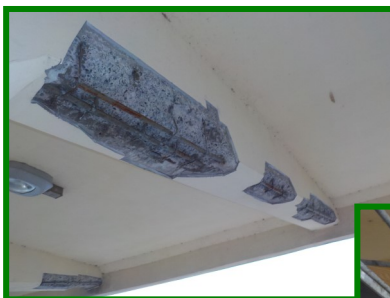
Broken out beam showing corroded reinforced steel

Each bay was visually checked for defects and then hammer testing. Once all defects were identified they were broken out and all loose debris was removed. Once broken out the steel was then treated with a Steel Primer. All defective areas were then shuttered and repaired. Once cured an Anti Carbonation coating was applied to the repaired area, blending in with the current promenade colour.

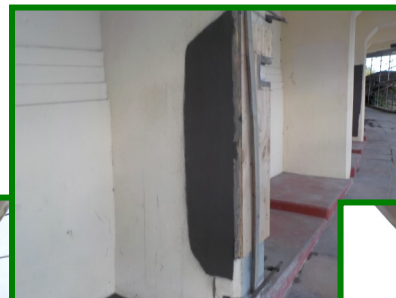
Shuttering around broken out areas ready for repair

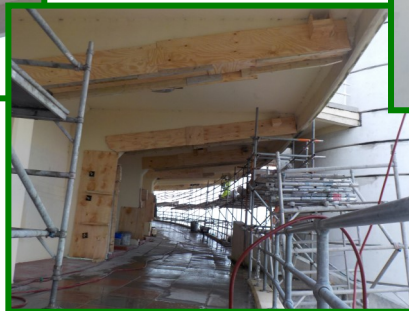
Repaired area

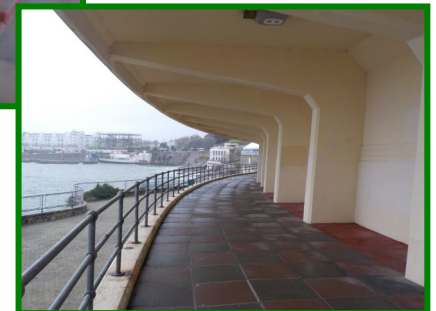
Finished look after Anti Carbonation Coating
