Project: Reception Tank Repairs

Client: Sustainable Energy Generation

Main Contractor: Ixora Energy

Date: February 2023—March 2023

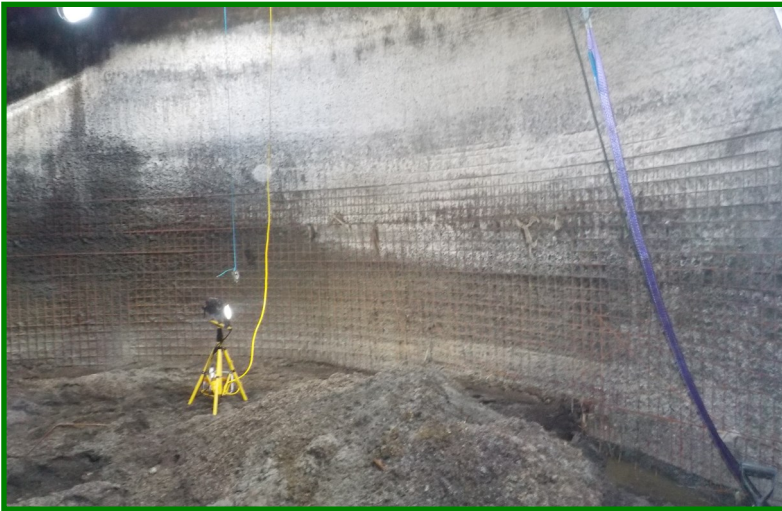
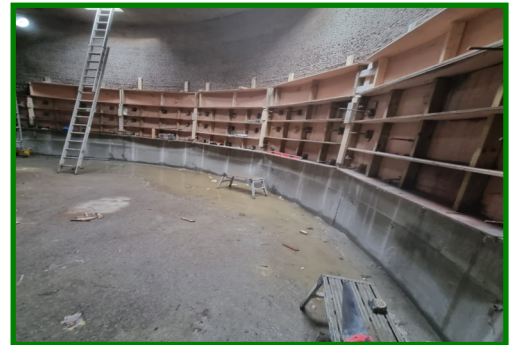
After years of storing lactose based fluids the high alkalinity had caused the surface concrete to erode leaving the steel reinforcement exposed. The bottom 2/3 of the tank needed to be built back up to its original profile and treated to protect from further deterioration.

The defective and loose friable concrete was removed using a hydro demolition technique, the steel reinforcement cleaned and treated. Where necessary new steel was fitted and tie wired to the original. Curved shuttering sections were constructed and secured using dywidag bars, drilling and fixing and timber bracing. The new sections were cast using weber advanced concrete a pre bagged high flow, high strength concrete. The shuttering being moved to each new area as work progressed.

After sufficient curing the tank was sprayed with Interline 955 Novalac vinyl Ester to protect against the aggressive chemicals to be stored in the tanks.
