Project: Civic Centre, Plymouth

Client: Plymouth City Council

Re-Fixing & Securing and Concrete Repairs

Date: July 2010

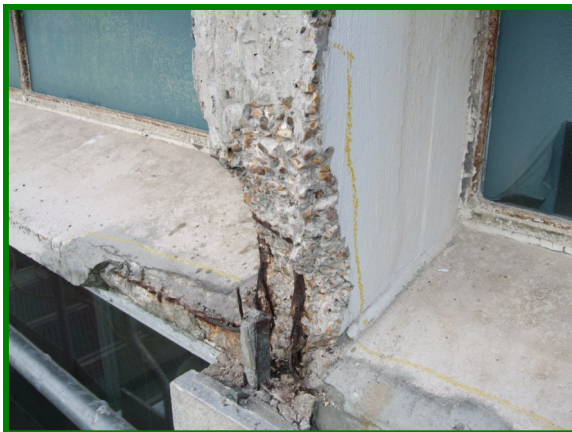
Spalling concrete to the face of the window feature with exposed reinforcement

South West Concrete Repairs were contracted to secure all the pilasters by drilling proprietary concrete screws through the pilasters and into the concrete structure behind. Visibly distorted pilasters or having signs of severe frame distortion behind were removed, the main concrete frame repaired using traditional concrete repair techniques and the pilasters refitted.
