Beech Farm Bridge

Cathodic Protection & Concrete Repairs

Case Study

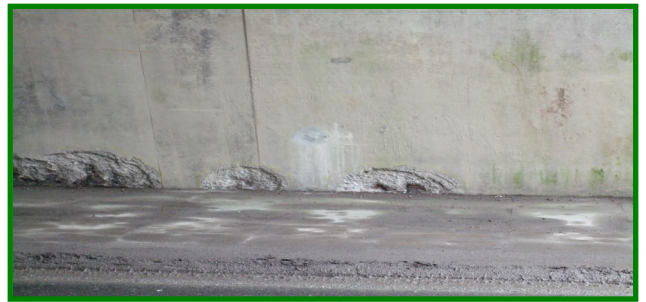
Water and de-icing salts along the 'splash' zone of the abutment walls to this road bridge have caused the reinforcement steel within the concrete to rust and corrode. This expansion due to the rust has caused the surface concrete to spall and crack leaving the reinforcement steel exposed to further attack.

A full concrete survey was carried out in order to determine the condition of the concrete and location and condition of steel reinforcement bars. A full concrete repair system was used in order to repair the defective areas. A Cathodic protection system was designed using Galvashield XP zinc anodes to provide localised protection to the perimeter of the patch repairs. Galvashield CC anodes were drilled and fitted to provide targeted corrosion control to the surrounding sound concrete. An anti-carbonation coating was used to provide further protection to the 'splash' zone of this roadbridge.
