# Bretonside Viaduct, Plymouth

Testing & Report and Concrete Repairs

**Project:** Bretonside Viaduct

**Client:** Plymouth City Council

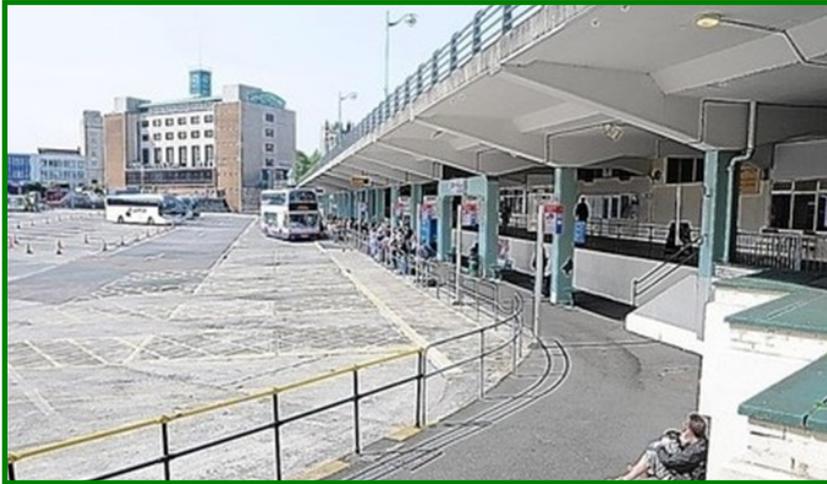
Built in 1959 Bretonside viaduct forms the covered area of the original Plymouth bus station. Now part of a new £53million redevelopment the original structure was showing signs of some deterioration. Before handover to the developer Plymouth City Council needed to be sure the concrete structure was in good condition. South West Concrete Repairs were commissioned to carry out a concrete condition survey which confirmed that whilst the soffits, beams and columns were in good solid condition there were some areas in need of concrete repair, especially to the concrete around the original glass blocks forming the central reservation which had numerous leaks over the years.

Redundant fixtures and fixings were removed and patch repaired over. Larger defects had the defective concrete broken out, steel reinforcement cleaned and treated with Flexcrete steel prime 841, a layer of Flexcrete Bond aid 842 applied before the repair using Flexcrete Monomix polymer modified cementitious repair mortar. In some of the larger defects Galvashield sacrificial anodes were fitted to give the repair additional electrochemical protection.
