**Project:** Seaton Sea Wall

**Client:** Environmental Agency

Concrete Repairs & Joint Renewal

**Main Contractor:** Bridge Civil Engineering

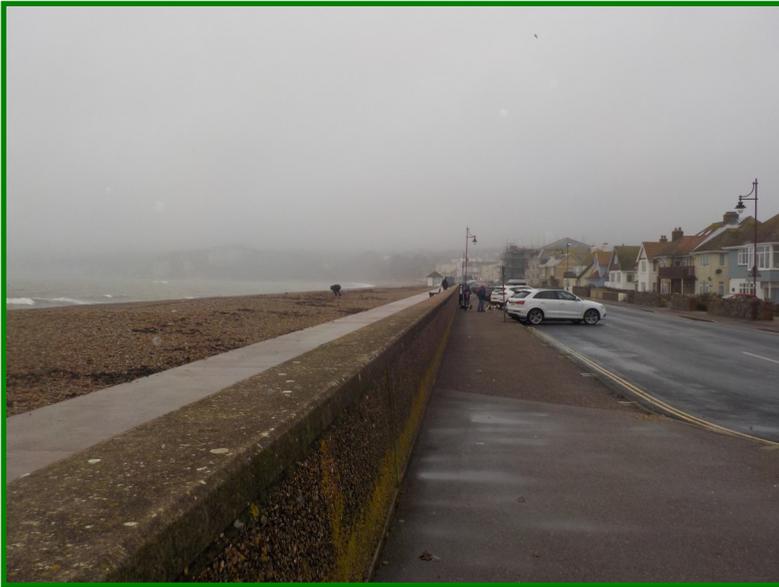
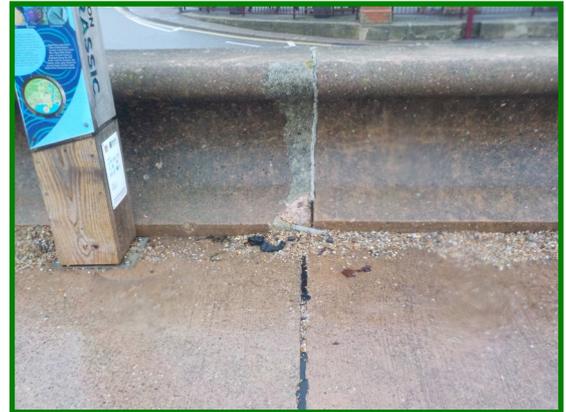
Due to sea salt, weather there was found to be expansion joint failure which would need repairing. On further inspection it was noted that there were also defective concrete on the joint edges and on some previous repairs. As part of the maintenance scheme these repairs were undertaken.

The defective areas were hammer tested to determine the soundness of the concrete and identify any hollow areas or defects. We then marking out the defect areas, removed the defective concrete back to 'sound', any corroded steel was cleaned and treated, an application of bonding bridge was applied and then finally repaired with a concrete repair mortar. To the defective joints, we disc cut both sides of the expansion joint, raked out existing joint to cleave clean, square –cut gap. Primed all surfaces and inserted polythene foam backing cord, applied Sika Pro 3 Joint sealant to the joint and then made it flush.
