**Project:** Polsloe Rail Station, Exeter

**Client:** Network Rail

Case Study

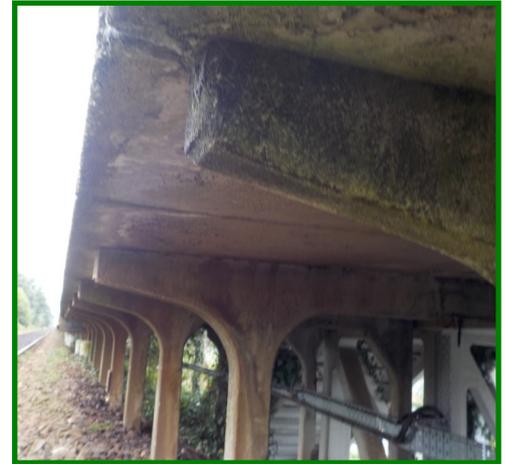
Polsloe Bridge is a suburban railway station that serves the Polsloe, Hamlin, Mount Pleasant and Whipton areas of Exeter. It was found that the rail station had defective concrete across the handrail columns, also on the main support trestles to underside of the walkway platform slab sections, the joints in-between these sections were also defective.

All defective concrete was removed and the reinforcing steel cleaned anodes were then tied onto the steel and currents recorded before treating the steel with anti corrosion paint, shuttering the area, and then repairing with Fosroc's Renderoc HB45.

To strengthen the columns that were supporting the platform, SWCR dug out ballast and cast a plinth around the insitu column. We then broke out defective concrete, scabbled the substrate, cleaned, then resin fixed dowels into the columns, followed by tying steel rings around the columns and tying a mesh to the circular ring. A circular shutter was then erected around each column and poured with Fosroc's Renderoc LA55.

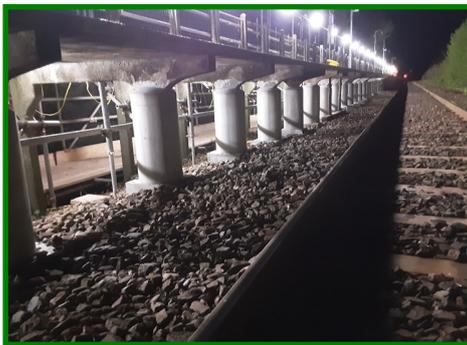
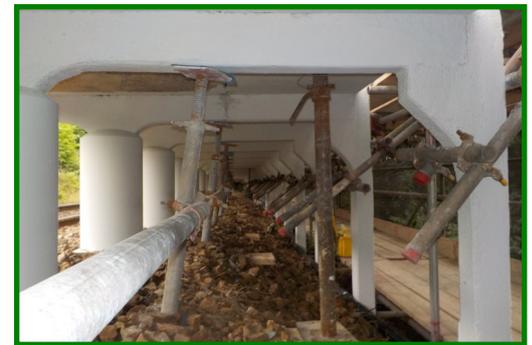
The site itself had difficult terrain where access to the platform was incredibly steep; a scaffold was provided to gain access up to the track and 2 lifts running across the outside edge of the platform. Lights were erected along the scaffold to illuminate the site as all works were to be conducted at night.

Network Rail assigned CentreGreat as the main contractor who then appointed SWCR to complete the works. The works would include, strengthening the trackside columns, traditional concrete repairs including galvanic anodes, protective coatings and joint renewal.
