Project: Totnes Civic Hall External Staircase

Client: South Hams District Council

Main Contractor: South West Concrete Repairs Ltd

Case Study

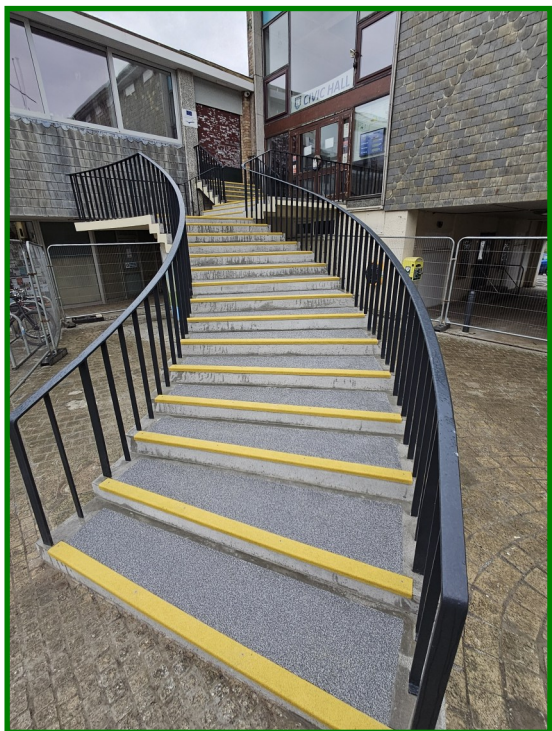
SWCR were asked to survey the staircase for defects and identified numerous areas of spalled and cracked concrete along with damage to the nosings of the staircase and steps which were very smooth and slippery.

The defective concrete areas were removed using mechanical breakers and the steel reinforcement cleaned and treated. Timber shuttering erected where necessary and repairs made using the Intercrete (formerly Flexcrete) repair system, Steel protector 841, Bonding Bridge 842 and Monomix HD repair mortars. The staircase was cleaned and prepared and then the Intercrete Bond Prime applied before two coats of Intercrete Monodex smooth anti-carbonation paint coating.

The stair treads were repaired before application of Degafloor B71 primer, followed by a base coat of Degafloor 465 RTU Dark Grey, whilst wet FB Seal Grey anti slip aggregate was broadcast over the top. Once cured, excess aggregate was swept off and then Degafloor 530 Seal was applied to encapsulate the anti slip and to finalise the coating system.
