Project: Trowbridge STW

Client: Wessex Water

Remedial Works to STW

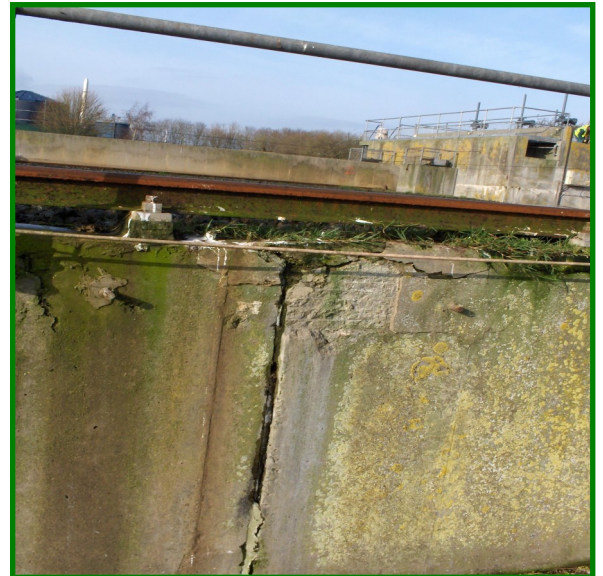
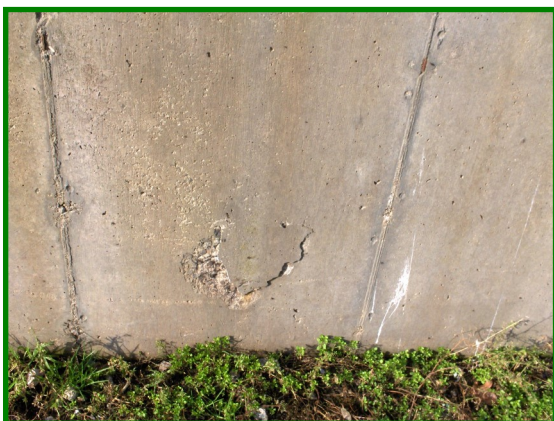
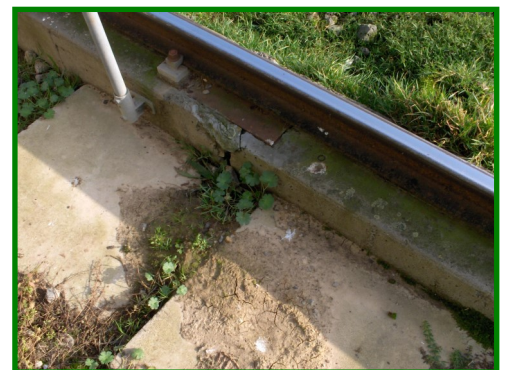
Numerous defects to the filter bed walls were identified by Wessex Water; they included spalling concrete with reinforcement bars showing, cracks running up the walls, expansion joints to walls failing and failing concrete under steel plates fitted for the sprinklers to run on.

High pressure power washing was used to remove surface contaminants and clean the surfaces to help with identifying any hidden defects. Redundant steel plates were removed and traditional concrete repairs to the defective areas under the plates and spalled concrete areas.

Sealant to expansion joints ripped out and edges made good and prepared followed by the installation of new polysulphide sealant.

Cracks were repaired by opening up the cracks and cutting horizontal slots across the cracks (crack stitching). Fitting new reinforcement steel to the slots embedded in epoxy resin and traditional concrete repair to finish.
