**Project:** Grain, Kent

**Client:** Alstom Power Ltd

Resin Injection Works

**Date:** March 2009

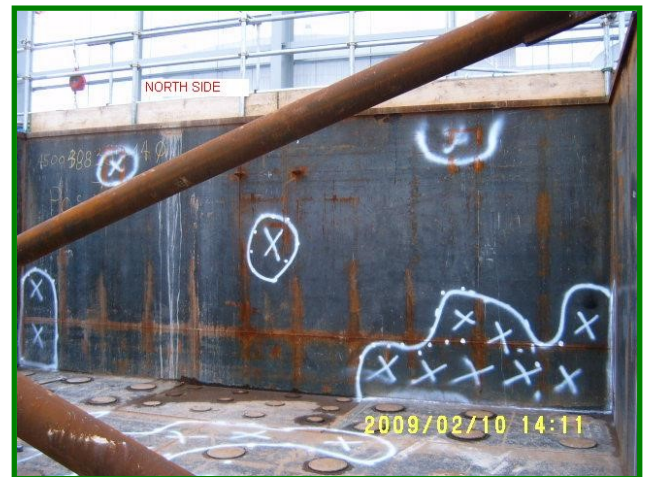
*Hollow/de-bonded area of wall marked out following hammer testing. The X's indicate where the holes were to be drilled.*

To drill through steel wall plates and resin inject to suspected hollows behind. The steel wall plates were hammer tested (sounding survey) to identify potential hollow or de-bonded areas. These areas were then marked out. The holes were drilled using a Mag drill and 16mm broaching bit in locations determined on site dependant on extent of hollow identified by hammer testing. Edges were sealed using a two part resin. Injection nipples were fitted with two part epoxy and allowed to cure. Fosroc Nitokit LV repair resin was mixed and poured into the relevant dispensing tubes, inject resin into the hole under pressure to ensure even spread and complete filling of the void. Levels were monitored and topped up accordingly. Once cured, the injection nipples were removed and surfaces made good.

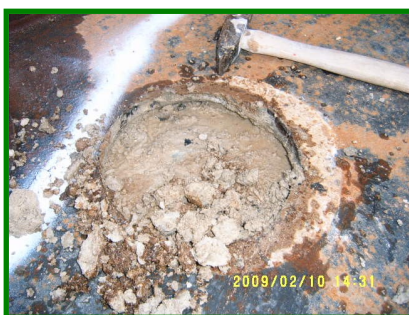
*Holes drilled through steel to concrete behind*
