Project: Plymouth Museum

Stonework and Concrete Repairs

Main Contractor: SWCR Ltd

Date: May 2012

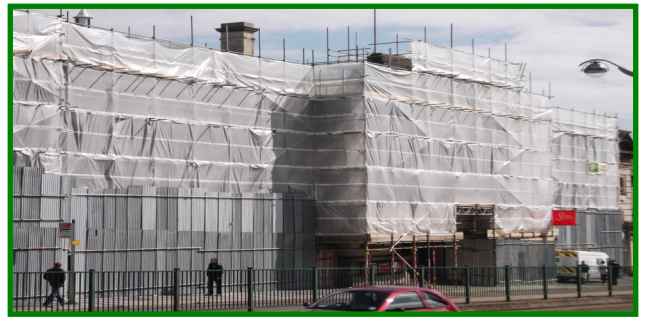
Leaks appearing within the building were traced back to defective coping finish on the low level parapet wall at roof level. The concrete/mortar forming the coping had cracked/spalled and broken apart allowing water to penetrate through into the solid masonry walls underneath.

The museum was then cleaned using a specialist herbicide cleaning agent to ensure the preservation of the stone. Once cleaned, we were then able to carry out a full survey of defects including hammer testing areas to check for 'soundness'. Concrete repairs were then carried out along with a program of removal of vegetation, raking out and re-pointing joints and cracks and masonry repairs.
