**Project:** Mount Wise Pools

Concrete Repair & Specialist Coatings

**Main Contractor:** SWCR Ltd

**Date:** August 2013

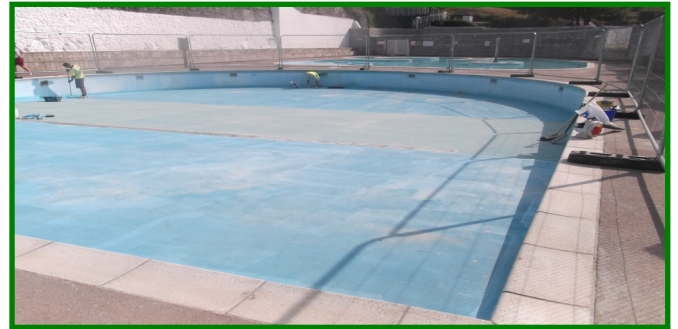
A large area of the pool base screed had failed; probably due to hydrostatic pressure forcing the sea water up through the screed before it had properly set during construction.

SWCR Ltd has attended the site on an almost annual basis for several years patch repairing the pool, but the middle section of the pool was eventually deemed unfit for purpose and required complete renewal.
