**Project:** Mount Wise Pools

**Client:** Plymouth City Council

Concrete Repair & Specialist Coatings

**Date:** August 2013

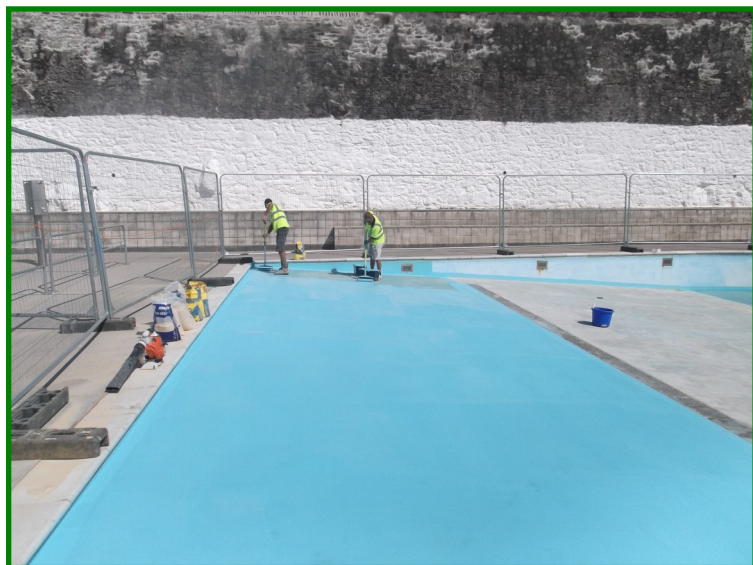
A large area of the pool base screed had failed; probably due to hydrostatic pressure forcing the sea water up through the screed before it had properly set during construction.

SWCR Ltd has attended the site on an almost annual basis for several years patch repairing the pool, but the middle section of the pool was eventually deemed unfit for purpose and required complete renewal.

SWCR Ltd were called in to renew the middle section of screed and carry out any other necessary repairs in order to get the pool ready for the summer season.

The original screed had to be hacked up using electrical breakers and grinders and the concrete below had to be prepared using floor grinders and pressure washing. A primer was applied to the newly prepared concrete surface followed by a new 25mm Ronacrete screed. Another coat of primer and two full coats of Polybond Pool Coating were applied to complete the project.
