Project: Earls Mill Road

Client: Amey Ltd

Testing & Report and Concrete Repairs

Main Contractor: SWCR Ltd

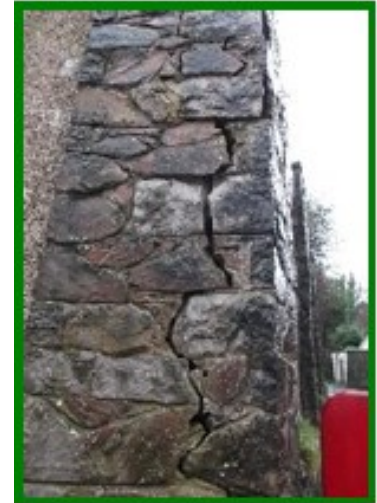
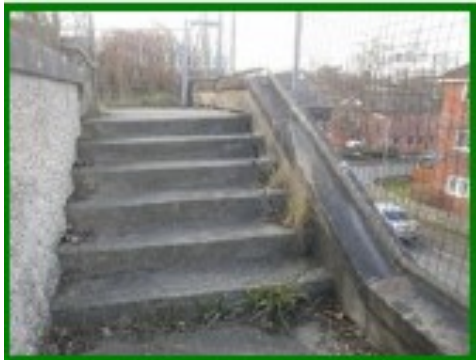
Following the appearance for several large cracks to the corner of the retaining wall and sinking of the steps on the inside of the wall, a full geotechnical investigation was carried out by John Grimes Partnership a firm of Civil, Structural and Geotechnical consulting engineers. The report concluded wall movement and sinkage of the steps was due to pressure from the saturated or settlement of the fill materials behind the wall.

The John Grimes Partnership proposed using Rock Anchors drilled into the rock behind the backfill and strengthening of the existing wall to prevent any further movement.
