Project: Huller House

Client: Generator Developments
Concrete Repairs

Main Contractor: Dawnus Construction Ltd

Date: April 2015— October 2015

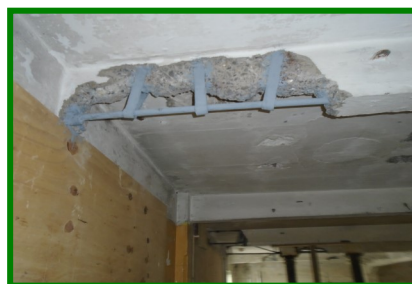
Broken out Beam, steel treated with Nitoprime Zincrich Plus

High Pressure Power washing to clean down areas and help identify defects was carried out. Survey and testing followed by full traditional concrete repairs were carried out to all defective areas in preparation for new internal and external finishes.

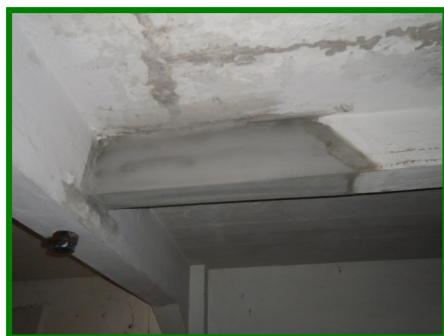
Beam repaired with Renderoc HB45

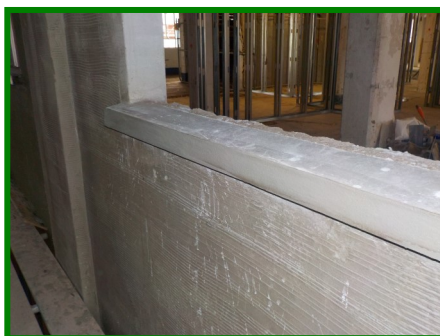
Coating finish to Elevation after repairs where completed using Renderoc ST 05
