**Project:** Mount Wise Pool

**Client:** Plymouth City Council

Remedial Works

**Main Contractor:** SWCR Ltd

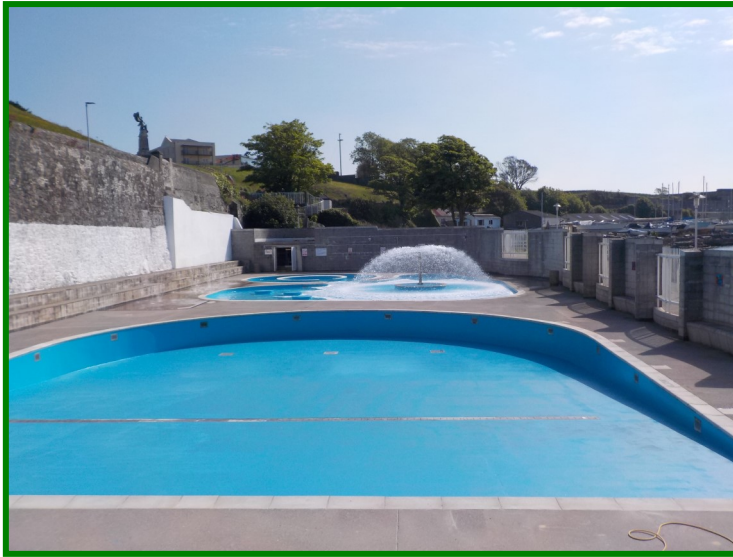
The pool paint coating was failing, with bubbling, cracking and flaking areas. The cause was most like due to hydrostatic pressure forcing sea water up through the floor slab during high tides.

A triple headed diamond floor grinder was used to remove all existing coatings from the pool base. Once all the coating were removed a high pressure power wash was carried out to ensure all dust and other contaminates were removed. Defective areas of concrete were uncovered during the preparation process which required repair before moving on to the next stage, renewal of Expansion Joints to the Concrete slab.

Once the repairs were complete and fully cured a layer of Coo-Var Dampshield was applied. The Dampshield is a two-component resin membrane that is tolerant to residual moisture in concrete floors. After allowing to cure, two coats of P101 Polyurethane Topcoat was applied to finish the pool.
