**Project:** Tiverton & Cridton  
**Client:** Mid Devon County Council  
**Main Contractor:** SWCR Ltd  
**Date:** January - March 2017

## The Problem

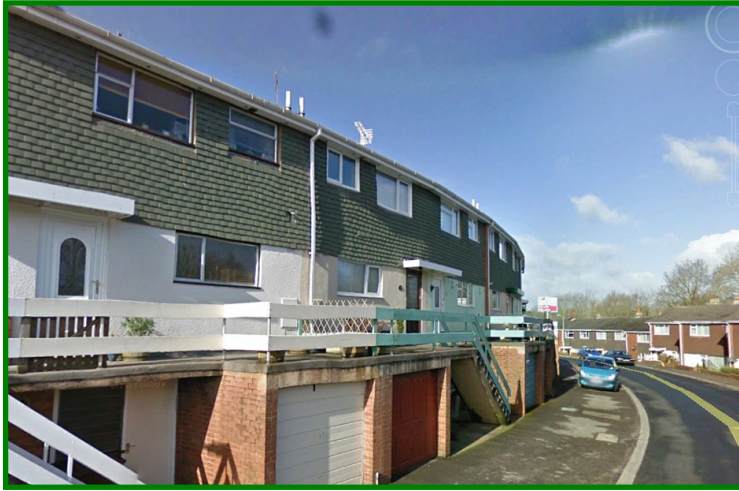
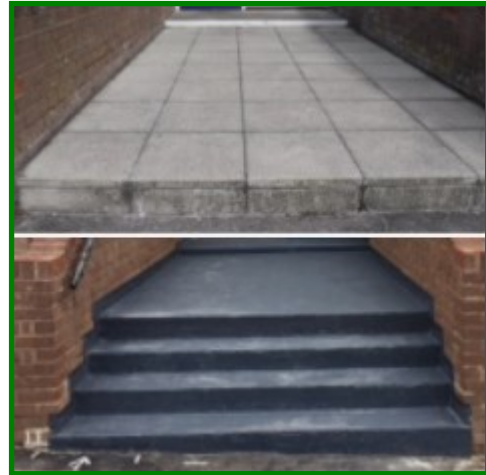
The underside of the concrete balconies and staircases to around 70 properties in several different streets in Tiverton and Cridton were showing signs of spalling concrete and exposed corroding steel reinforcement.

The damage was being caused by water penetration through the balcony and step surfaces reacting with the steel reinforcement. High pressure power washing to remove contaminants and debris followed by repairs to the surfaces where necessary and then the application of a TorDeck Balcony anti-slip Coating system. The system comprises of a 3 part edge detail and 4 part main walkway system incorporating a fibreglass bridge matting layer.

Once the top surfaces were sealed the undersides could be repaired using the Flexcrete Repair system. Spalling concrete and defective concrete is broken out, steel reinforcement cleaned and treated with Flexcrete steel prime 841, a layer of Flexcrete Bond aid 842 applied before the repair using Flexcrete Monomix polymer modified cementitious repair mortar. Some areas were also treated with a re-profiling repair render to give additional cover over the steel reinforcement before a final application of an ant-carbonation coating of Flexcrete Monodex smooth.
