# Pottington Flood Wall

Joint renewal and Concrete Repairs

**Project:** Pottington Floor Wall

**Date:** September 2020

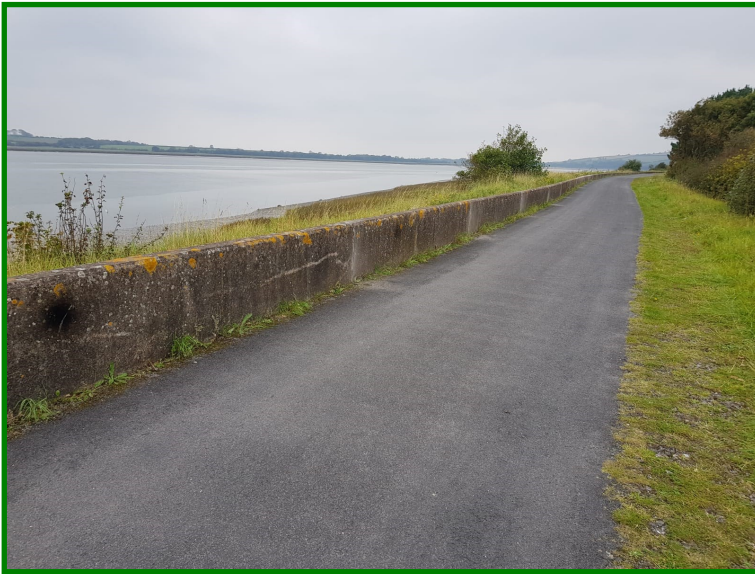
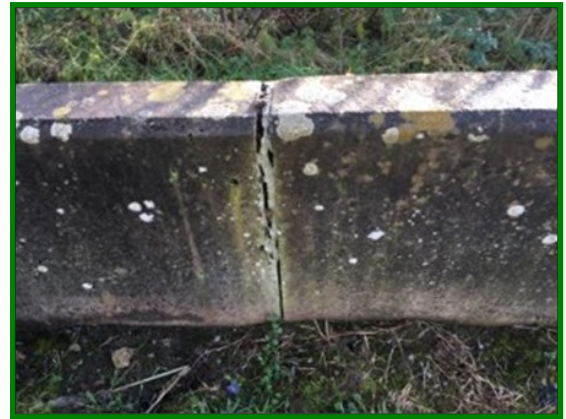
Along the flood wall it has become apparent that many of the wall joints had failed and required replacing. There were also some minor repairs which had been found.

To renew the joints we first raked out the existing joint, then using a diamond blade grinder to grind all the edges down to leave a clean, square-cut gap. Once clean the surface was primed and a polythene foam backing strip was inserted. The joint was then finished off with a 1 part Polysulphide sealant (Sika Pro3) and tooled off to leave a flush finish.

The minor concrete repairs were broken out, cleaned, primed and repaired using the traditional concrete repaired method.
