## Chesil Cliff House, Croyde

Concrete Repairs & Crack Stitching,

Project: Chesil Cliff House, Croyde **Client:** Palmer Birch Concrete Repairs, Crack Stitching& **Resin Injection** Date: June 2020

# Case Study

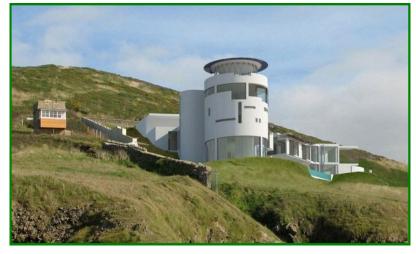
Various cracks that had been identified required repair using crack stitching techniques. Crack stitching bars are stainless steel reinforced rods that are chemically bonded into bed joints to stitch together cracks, redistributing tensile forces and stabilising a structure. The bed joints are cut out and then the crack stitching bar is grouted in place to prevent any future movement. There were also cracks around the external pool wall, which we resin injected a PU resin to stop any future leaks.

Defects to other concrete areas were also identified which were repaired using traditional concrete repair techniques followed by application of an MCI Migration Corrosion Inhibitor impregnating solution.

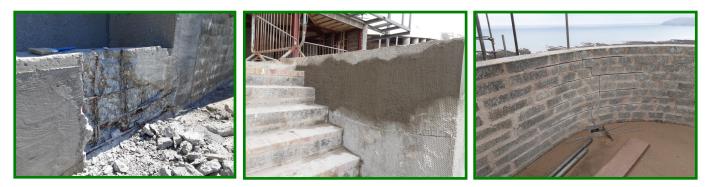
This property featured on the Grand Designs Television programme "saddest episode ever" episode when the owners who were planning to build an iconic lighthouse home ran out of money to complete the works. The project was left untouched for 10 years and during that time various uncompleted areas which had left concrete and steel unprotected had started showing signs of deterioration. HOP Consulting were brought in for guidance on the remedial works necessary to bring the project back online, once funding became available to complete the project.
