North Drain Pumping Station

Concrete Repairs, Crack Stitching, Resin Injection & Joint Renewal

Project: North Drain Pumping Station

Date: September 2020

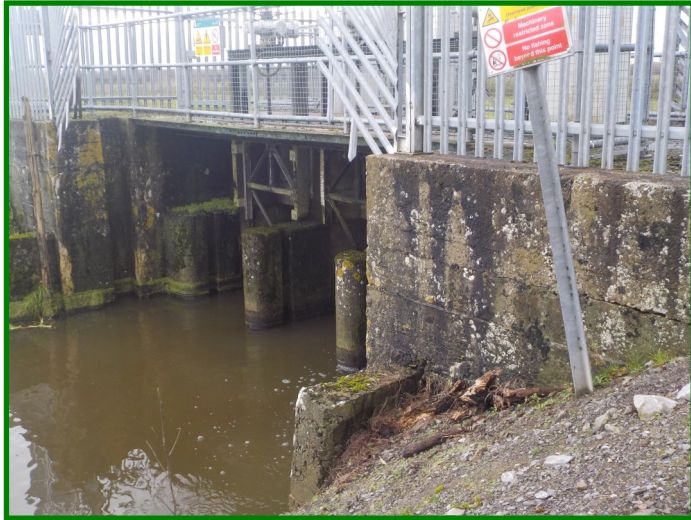
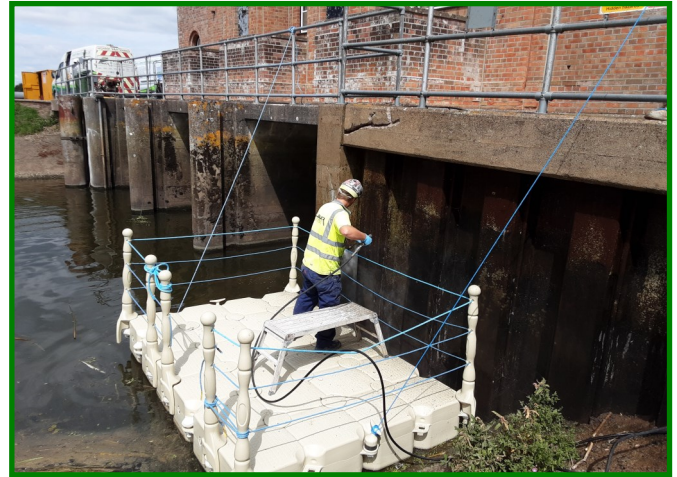
The Pump House Penstock Structure and Gravity Outfall Structure were in need of various repair works as part of North Drain Pumping Station's improvement programme, for the Environment Agency.

Pressure washing the walls to remove any contaminants and loose debris before completing various types of repairs to the gravity outfall structure. The works included were Crack stitching, Resin Injection using Tampur 150, traditional Concrete repairs following the Intercrete (formerly Flexcrete) repair system and joint renewal using Sikaflex Pro 3. All the works for the Gravity Outfall were accessed from a Floating Pontoon.

On the Penstock Structure concrete repairs were required to the structures soffit. Traditional concrete repairs were completed also using the Intercrete repair system.
