Montpelier School, Plymouth

Concrete Repairs, Crack Stitching & Lead Flashing

Project: Montpelier School, Plymouth

Date: August 2022

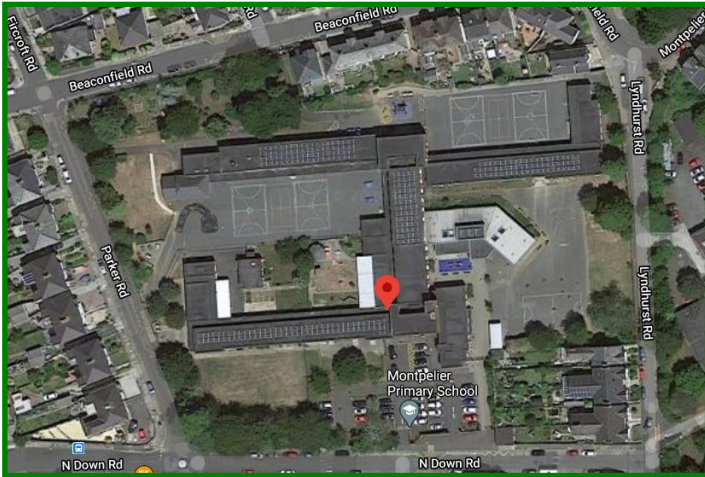
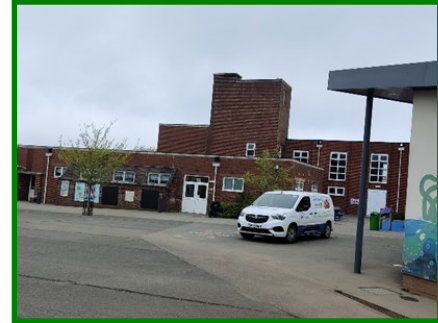
There were five sets of defects to the school identified: defective concrete, failed expansion joints, cracks to brickwork, lack of lead flashing above lintels and the capping to the chimney including several courses of brickwork brickwork was de-bonded.

Each area requiring concrete repair had all defective concrete removed and the reinforcing steel cleaned and treated before shuttering and repairing. SWCR also cleaned primed and painted with anti-carbonation paint for prolonged life.
