## Plymouth Argyle, Plymouth

Concrete Repairs

Project: Plymouth Argyle Lower TerraceClient: Plymouth ArgyleMain Contractor: GL Events UK LtdDate: October 2022

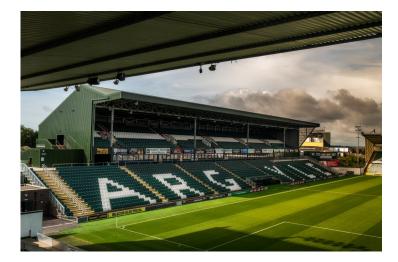
Within the Plymouth argyle grounds, there were two sets of steps that had several chips throughout. This was due to a new handrail being put in place and when fixed has caused the edges to chip.

In order to remedy this SWCR suggested to break out the defective concrete and repair the area. SWCR decided to use an epoxy mortar to complete the repairs, as the defects were small yet the area was highly trafficked, we decided that an epoxy mortar is the best choice for the repair. After removing the defective concrete using percussive breakers the area was primed before applying the RBS Epoxy Mortar Lightweight– Resin. The area was then finished to the existing substrate profile

In some areas these chips were present on the expansion joints. In this case, the sealant was taken out, the repair applied and the sealant reinstated. This ensured there was a seal between the expansion joint and the concrete.
