# **Plymouth Guildhall**

Concrete Repairs and Protective Coatings

Project: Plymouth Guildhall **Client:** Plymouth City Council Concrete Repairs and Protective Coatings Main Contractor: SWCR Ltd Date: August 2008

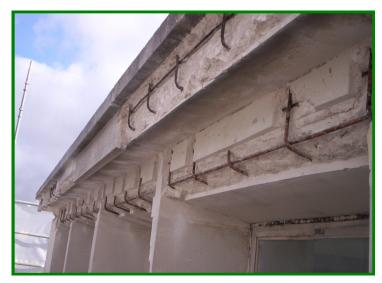
Severe spalling and cracking of the concrete caused by the expansion of corroding reinforcement bars within the concrete was causing serious concern for this historic monument. Numerous large cracks were identified which could cause large lumps of concrete to fall creating a major safety issue for anyone below.

Defective concrete around the steel reinforcement cut away ready for cleaning and treatment of the steel.

Works entailed: high pressure power washing of the concrete viewing chamber, the identification and full repair of defects including renewal of reinforcing bars, application of migrating corrosion inhibitor (MCI) and application of anti -carbonation coatings.

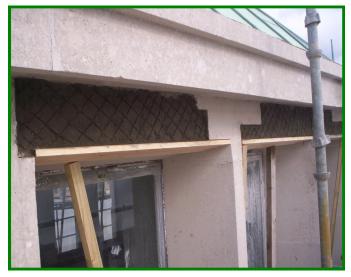
After steel treated first layers of repair mortar placed and 'scratched' ready for next layer.
