Project: Cattewater Barges

Client: Plymouth Harbour Master

Testing & Report and Concrete Repairs

Date: September 2012 & June 2013

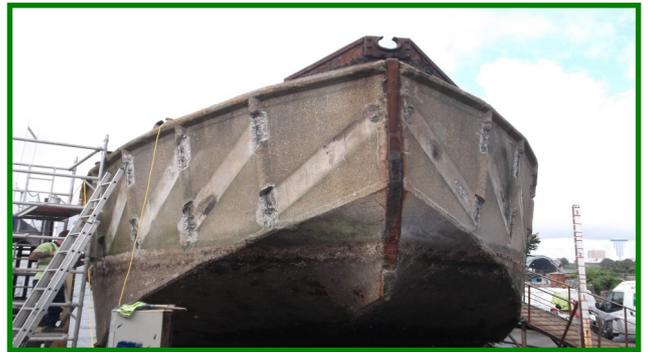
A pair of concrete barges in Cattedown Harbour had some of the concrete ribbing removed previously to fit timber fenders to protect boats tying up to the barges.

Salt water had penetrated into the concrete where the concrete is exposed and the reinforcement within was beginning to corrode causing spalling and cracking.

In order to access the areas, the barges needed to be beached. A full concrete survey was carried out in order to determine the condition of the concrete and location and condition of steel reinforcement bars. A range of concrete testing was carried out so that the cause of deterioration and depth of carbonation could be fully determined.

Following the testing, a full report with recommendations of the best course of action for repair was compiled.

A full concrete repair system was adopted in order to repair the damaged areas and a specialist coating applied to give added future protection to the barge.
