Project: Princesshay , Exeter

Client: The Crown Estate Via Workmann LPP

Main Contractor: Fifields Construction

Date: March - April 2016

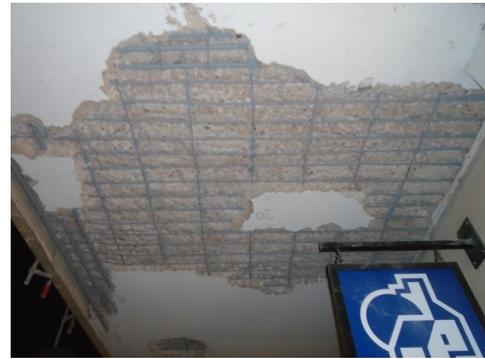
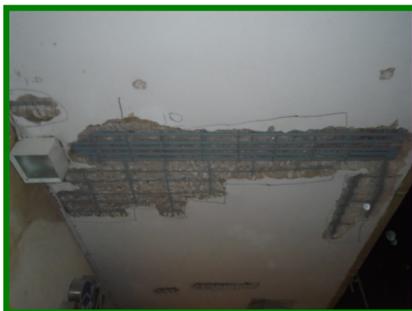
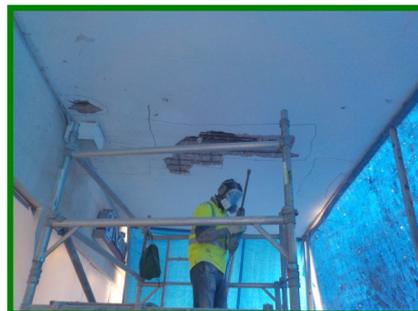
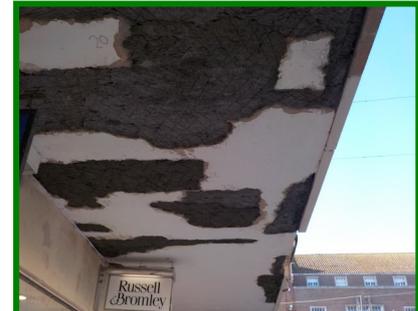
Underneath several shop canopies there were various signs of concrete deterioration, spalling, cracking and rust staining with some areas of exposed reinforcement

Each Defective area was Acoustic Hammer Tested and marked out. Once these areas were fully identified they were then broken out, with hand held breakers to expose in and around the steel reinforcement. Cleaning of the steel reinforcement was then carried out including replacement of any badly corroded reinforcement bars. These areas were then treated with a Steel Protector/primer. Temporary shuttering was erected where required and the application of a Bonding Aid was applied to the existing Concrete surface. Concrete Repair mortar was then applied to the broken out areas, finished with a float to ensure the surface finish matched existing. Once the repairs had cured the shuttering was then removed and made good. An application of Fosroc Dekguard Primer was then applied followed by 2 coats of Fosroc Dekguard S Anti-Carbonation Coating
