Project: Harbour View Hotel, Torquay

Client: Torbay Council

Concrete Repairs & Carbon Strengthening

Date: October 2020

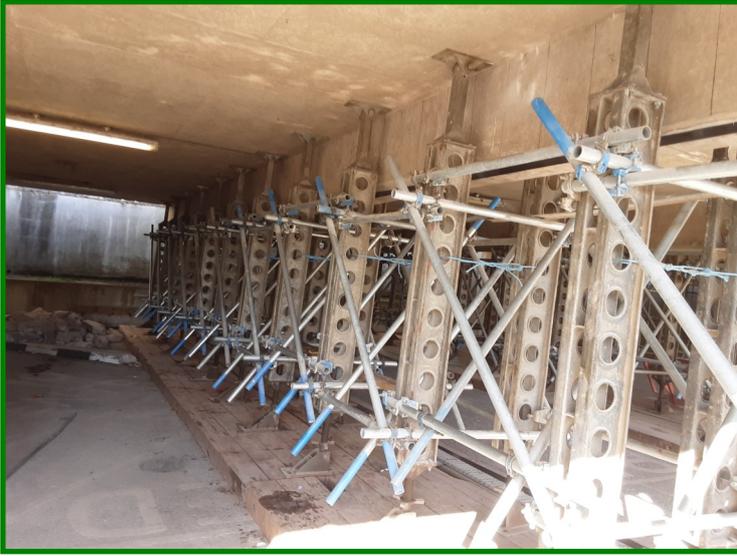
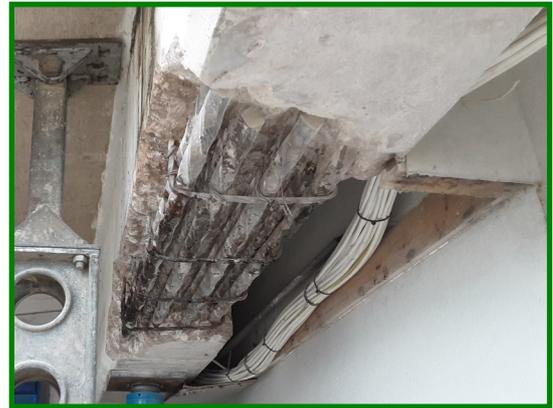
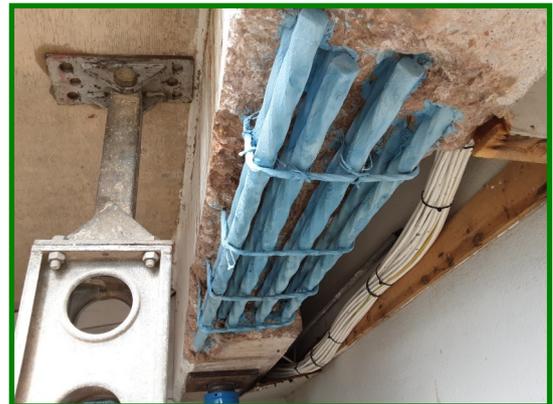
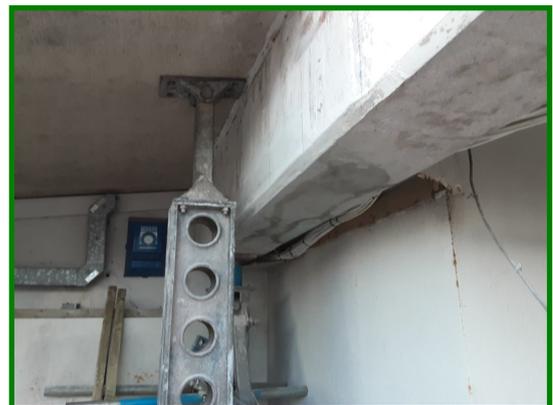
A structural inspection condition survey of the car park was completed in June 2020, which found that concrete repairs were needed to Beams and soffits. And that three of the reinforced concrete beams needed carbon strengthening to mitigate the shift in bending.

The defects to the soffit and underside of the beams were repaired using traditional concrete repair methods. The defective concrete was broken out, steel reinforcement cleaned to remove any corrosion and then primed with a steel protective coating, finally a bonding aid was applied and the defect repaired with a polymer modified concrete repair mortar.
