Project: Shoreline Restaurant & Bar, Paignton

Client: Torbay District Council

Concrete Repairs & Anti Carbonation Coatings

Date: Jan 2021 & June 2021

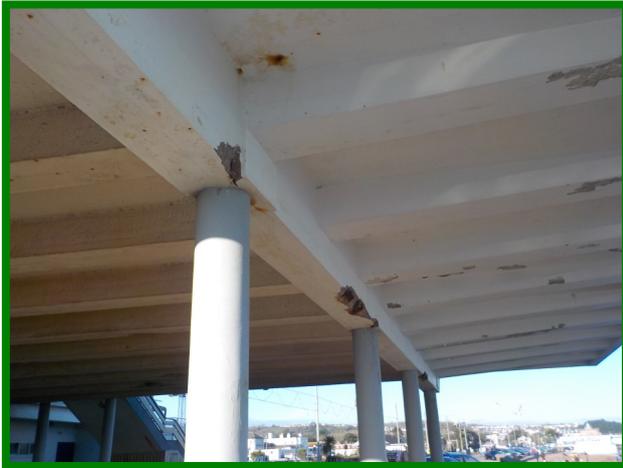
Shoreline Restaurant overhangs Paignton Eastern Esplanade. The columns, beams and soffit were showing signs of steel reinforcement corrosion caused by the aggressive sea side environment.

Following acoustic hammer testing to identify defective areas, traditional concrete repairs were carried out. Using the Mapei Repair system. To protect against further corrosion sacrificial anodes were fitted to some of the larger repairs and all of the concrete elements were treated with an anti carbonation coating.
