Project: East Street, Newquay

Concrete Repairs & Coatings

Date: July 2023—August 2023

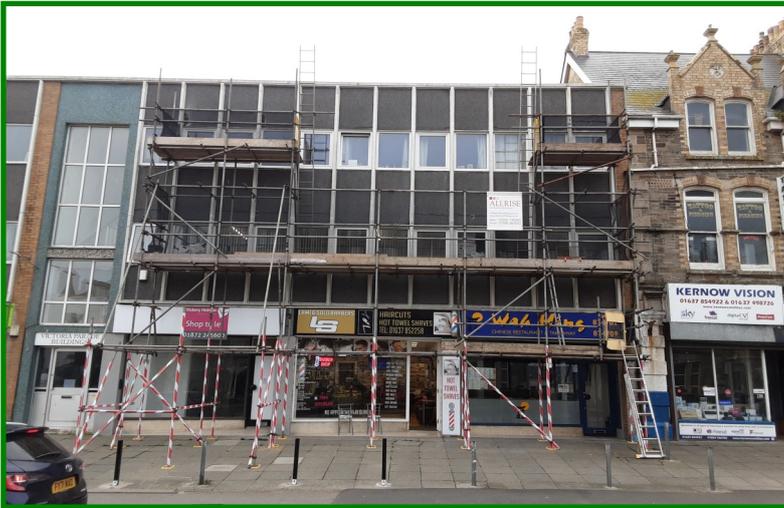
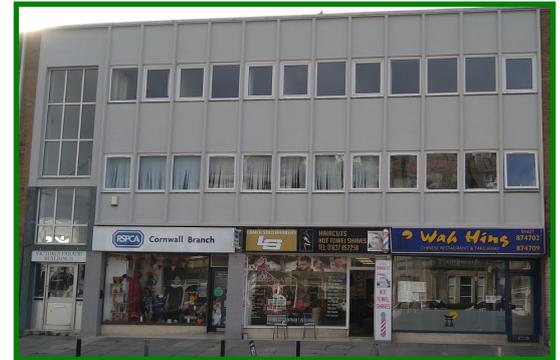
East Street is within the city centre of Newquay, a popular tourist Cornish hotspot. SWCR carried out an investigative survey on the concrete elements at the request of MBA Consulting. The survey identified defective concrete sections internally and externally and the presence of carbonation which does adversely affect the long-term performance of concrete.

The internal soffits needed temporary propping during the repair works to the concrete encased RSJ beams. The defective concrete was broken out, steel flanges cleaned and painted with protective coating before repair with Intercrete 4801 a heavy duty repair mortar.

The pilasters were fixed back in place using Recca, Rechem Resin P380 and after repair the external panels were treated with Intercrete 4820 a leveling render to give additional protection. The external areas were then painted with a two full coats of anti carbonation coating to give the building extra protection and a full uniform finish.
