**Project:** Fire Station Drill Towers, (multiple)

Concrete Repairs

**Date:** January 2023

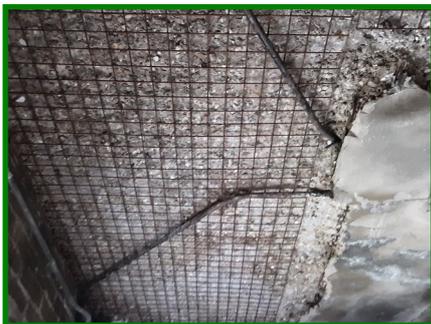
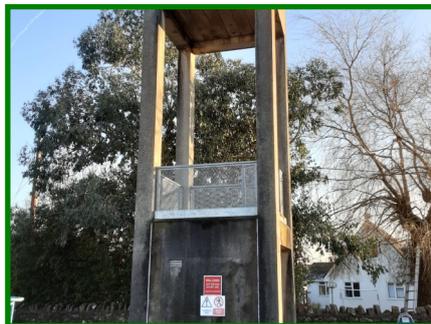
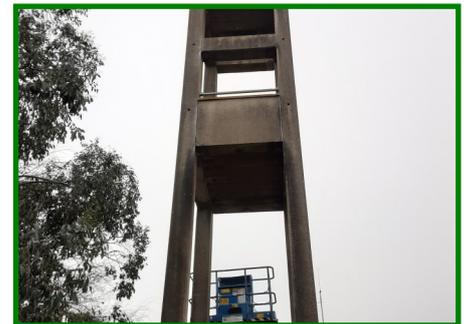
Multiple fire stations required concrete repairs to the practice drill towers. The fire stations were at; Yeovil, Frome, Cheddar, Nether Stowey and Burnham on Sea. All drill towers were of similar detail. Large areas of the tower had spalling concrete and large brackets supporting the cross beams. A mobile elevated work platforms (MEWP) was required to gain access to the towers to complete the works.

The Yeovil Drill tower required large repairs which were accessed internally. The other drill towers were repaired via MEWP (externally). Each bracket was cleaned from rust and treated with anti corrosion paint. Many of the brackets had blown the concrete caused by the rusting expansive forces. Each area was broken out, steel cleaned and painted with an anti-corrosion paint, shuttered and then repaired using Fosroc's Renderoc HB45.

SWCR made the joints between the frame of the building into expansion joints, by cleaning the sides of the joint, priming, inserting backing foam and applying sikaflex pro 3 to the area and tooling off. On Burnham on sea Fire station, Yeovil and Frome Drill Towers, Res-tec Flexitec 2020 waterproofing system was used on the floors to prevent any further water ingress.
