160 Armada Way, Plymouth

Concrete Repairs, Joint Renewal & Specialist Cleaning

Project: 160 Armada Way

Case Study

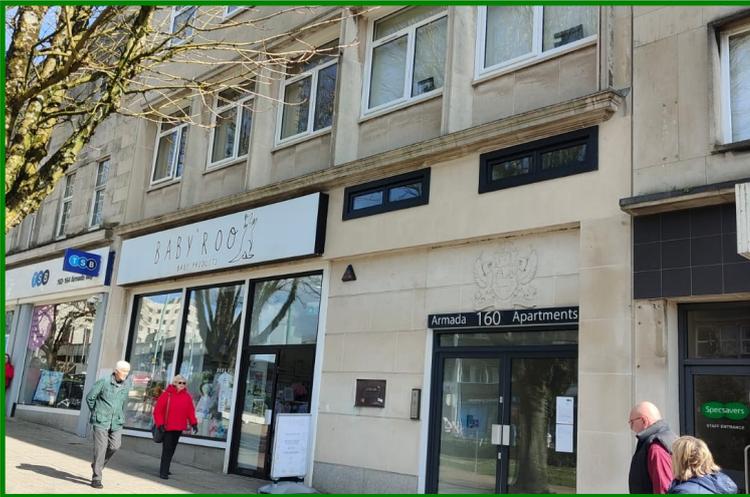
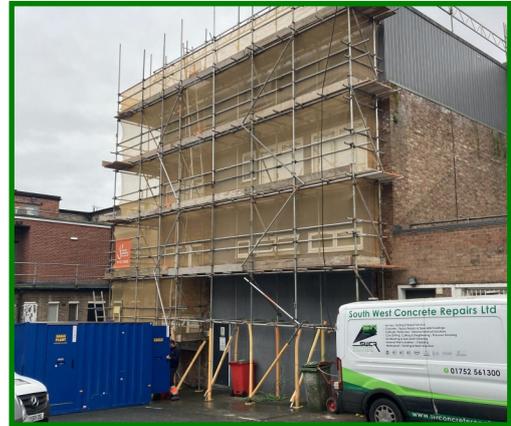
The building has been in use for years and therefore due to weather and other factors, the building had areas of defective/spalling concrete, loose/perished mortar joints, failed expansion joints and moss, algae and vegetation build up on the external facades, also lead flashing replacement to window heads.
