Plymouth Hoe Promenade

Canopy Strengthening and Concrete Repairs

Canopy Strengthening & Concrete Repairs

Date: April 2002

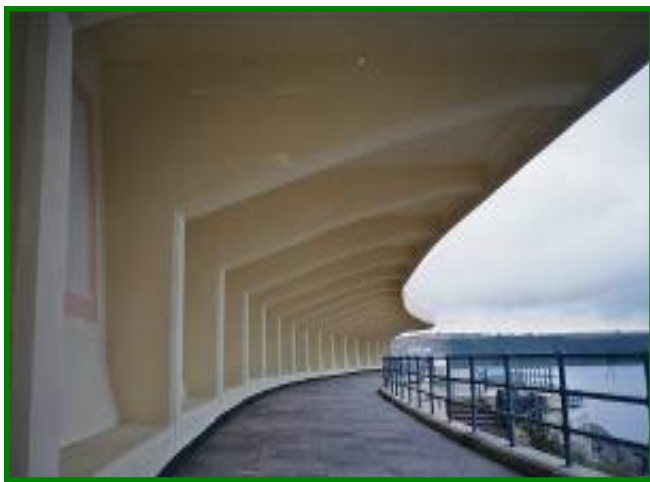
Canopy underside showing structural support

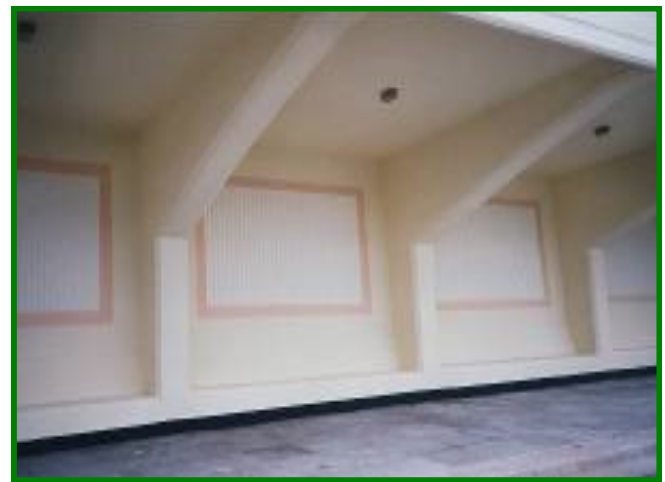
Rear walls showing ribbed feature panels
