Project: Tinside Lido Pool

Client: Plymouth City Council

Renovation & Refurbishment Works

Main Contractor: Interserve Civils

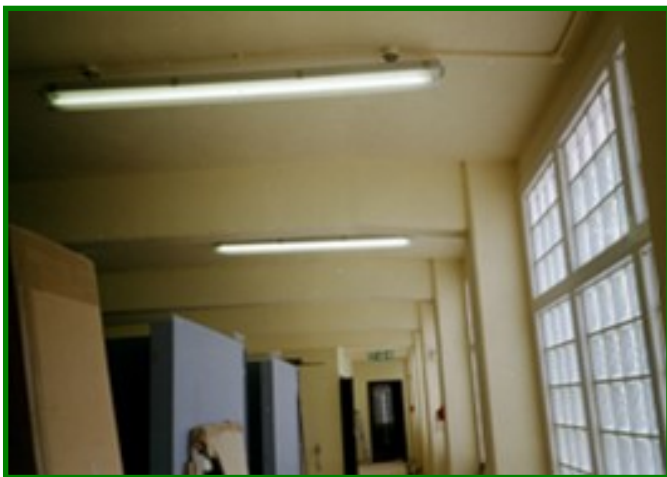
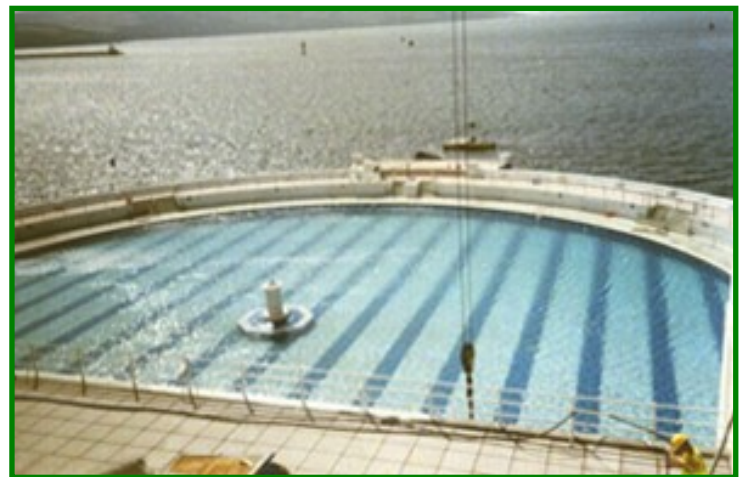
Tinside Lido Pool had been left abandoned for years. Its renovation revealed concrete defects to the concrete base of the pool and many defects to the pool house building structure.

The project included the excavation of the existing concrete base of the pool and complete renewal including all the necessary steel reinforcement and formwork, grit blasting to remove old coatings followed by structural concrete repairs and application of specialist protective render and anti-carbonation coatings to the changing rooms, stair tower, sides of the pool, perimeter seating areas, shelters and sun deck, new roof coatings and slabbed areas, new coloured concrete to the decks, redecoration, new handrails etc.

South West Concrete Repairs Ltd were sub-contracted to carry out the grit blasting, concrete repairs, specialist cementitious render finishes to walls and application of specialist anti-carbonation coating.
