# Prince of Wales Pier, Falmouth

Concrete Repairs

**Project:** Falmouth Pier

Date: February 2008

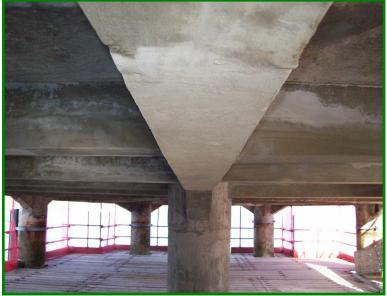
## The Problem

Years of exposure to the marine environment had caused serious deterioration to these concrete beams and columns. Large areas of spalling concrete with steel reinforcement exposed and cracking was evident throughout the structure.

View showing defective beams in the foreground and shutters fitted for re-casting towards the rear

Due to cost implications and budget restrictions, a long term plan was developed where 2 bays were renovated each year over a five year plan.

Removal of deteriorated concrete, cleaning and/or replacement of reinforcement steel bars and repairing or re-casting of concrete sections was carried out.
