**Project:** St Margaret Mary's Church, Plymstock

**Client:** Diocese of Plymouth

**Main Contractor:** SWCR Ltd

**Date:** October 2016

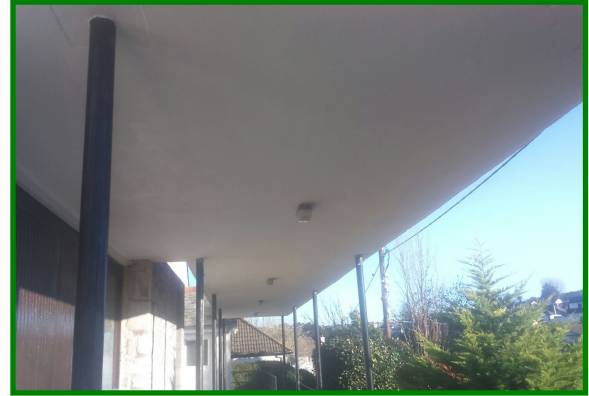
We were contacted by, Diocese of Plymouth, to have a look at the entrance canopy to St Margaret Mary's Church in Plymstock, Plymouth. The canopy had various areas of spalling which have occurred due to the Asphalt Roofing leaking over a period of time.

Due to the ingress of water from the leaking roof, the asphalt and mineral felt coatings needed to be removed, the deck power washed to remove any contaminants and debris. Then once dry a fluid applied roof coating of Decothane SP was applied to the roof. This 3 coat system incorporates the use of a Reemat Premium Glass Fibre Reinforcement matting and gives a fully seamless roof coating when completed. Once satisfied that the leaking had stopped, the spalled areas were repaired. These areas were broken out, the steel reinforcement cleaned and treated to preserve and then repaired with a repair mortar. Once all repairs were completed and cured a levelling mortar, Monolevel 844SP was applied, this then gives an additional layer of protection to the underside of the canopy.
