**Project:** Milford Schools, Yeovil

**Client:** Somerset County Council

Concrete Repairs

**Date:** July - August 2018

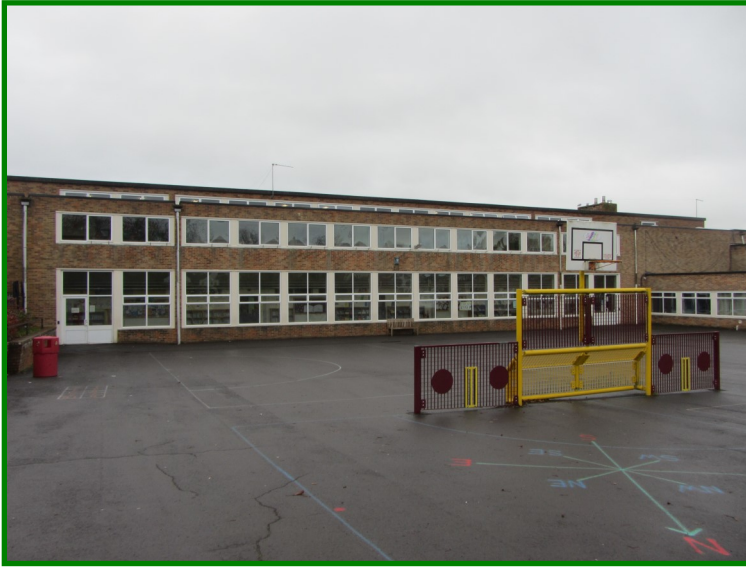
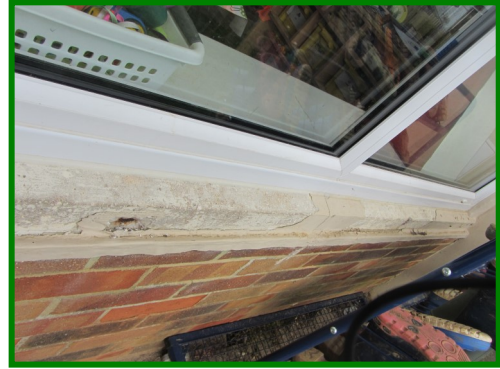
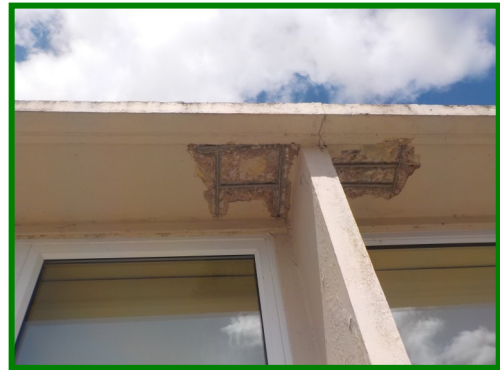
We were contacted by Somerset County Council to have a look at the primary and infant school. The concrete elements (window surrounds, columns, cills etc) throughout both schools had cracking and spalling of surface concrete, with some areas of exposed reinforcement bars.

Each elevation was visually checked for defects and hammer tested. Once all of the defects were identified they were broken out and all loose debris was removed. Once broken out all of the steel reinforcement was cleaned and treated with a steel primer. Each defective area was then shuttered and repaired.

Products used: Intercrete 4800 (Monomix), Intercrete 4871 (Steel Reinforcement Protector 841), Intercrete 4812 (Bonding Bridge)
