Project: Leighton Terrace Car Park, Exeter

Concrete Repairs

Main Contractor: Bridge Civil Engineering

Date: Jan 2019

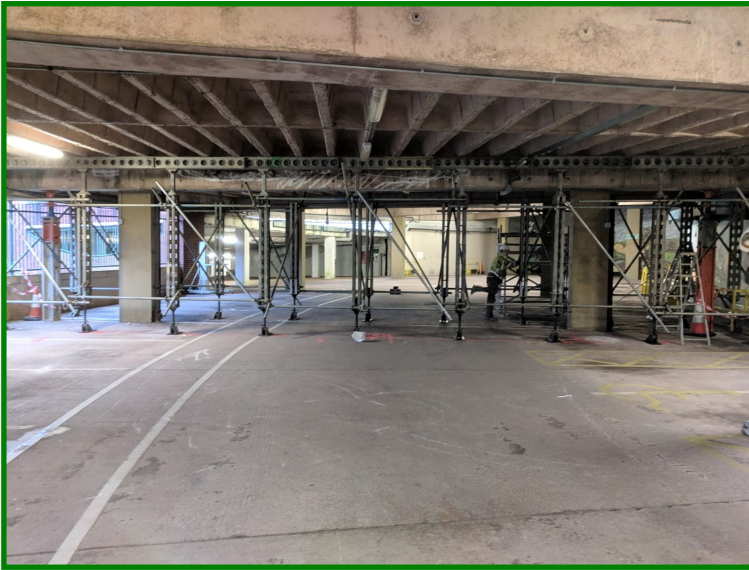
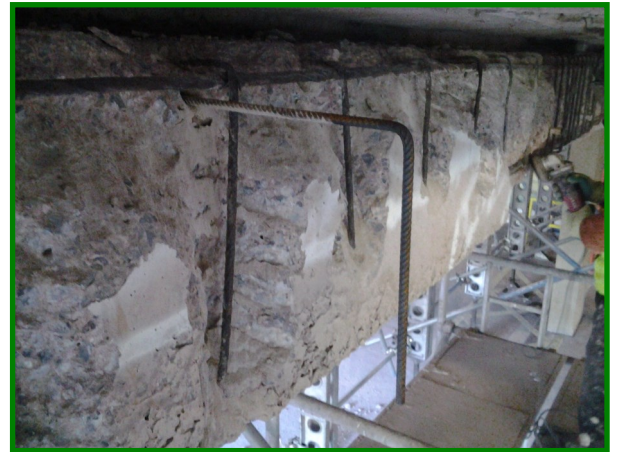
The beam on the underside of the carpark had various signs of concrete deterioration, spalling, cracks and some areas of exposed reinforcement. Due to the sheer amount of concrete defects to the beam, this posed a health and safety risk and needed to be rectified.

Due to the health and safety risk, SWCR had to erect temporary propping to support the soffit above the beam. Once the temporary works were complete SWCR were able to hammer test and mark up the defective areas that needed repairing. Once defective areas were fully identified they were broken out, with hand held breakers to expose the steel reinforcement. Cleaning of corroded steel reinforcement was then carried out including replacement of any badly corroded reinforcement bars and link bars. These areas were then treated with a steel protector/primer. Temporary shuttering was then erected where required and the application of the bonding aid was applied to the existing concrete surface. Concrete repair mortar was then applied to the broken out areas, finished with a float to ensure the surface finish matched the existing. Once the repairs had cured the shuttering was then removed and made good.
