Project: Lynher, Tavy & Tamer Towers, Devonport

Concrete Repairs

Date: June & July 2020

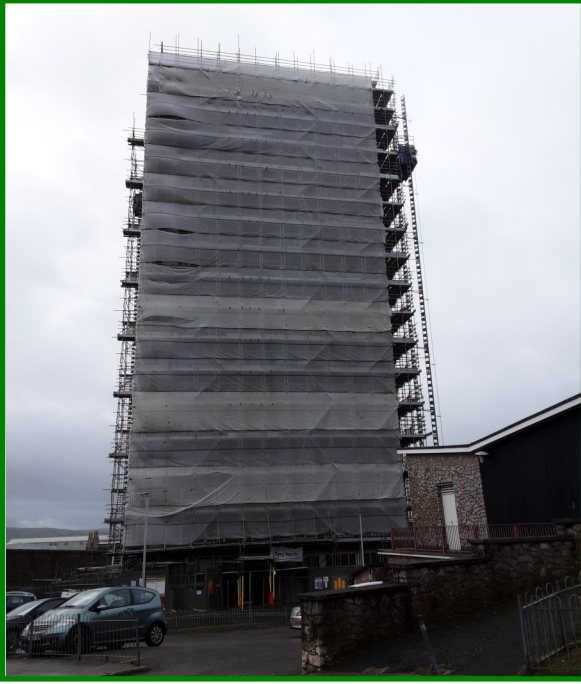
Following a Structural Report which had been completed on the 3 Devonport Towers and a further site visit from SWCR, it was found that many of the window heads, cills and reveals were defective and required concrete repairs works to be undertaken on the 3, 15 storey block of flats. Along with the concrete repairs, some new concrete spreaders were required to be installed on the roof of all 3 Towers.

The defective concrete around the windows were hammer tested for soundness, broken out to the depth, width and length required. Once broken out the areas were treated with Intercrete 4871 (Steel Reinforcement Protector 841), Intercrete 4812 (Bonding Bridge 842) & repaired using Intercrete 4803 (Monolite).

We also installed 2 new concrete spreaders per block as per the specific design provided on drawings. We resin anchored 4 steel bars per new spreader, adding further steel reinforcement by bending into shape around the 4 steel anchor bars to form a cage. Once the cage was in place, we then shuttered around it and poured RBS Rapid Concrete into it. Finally after curing overnight, we removed the shuttering and made good.
