Project: Avonmouth WRC, Bristol

Client: Wessex Water

Concrete Repairs & Roof Coatings

Main Contractor: SWCR LTD

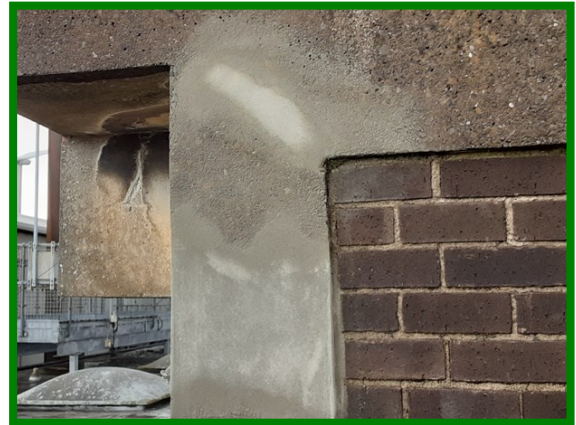
A structural survey complete by Mott MacDonald identified defects around the building and on the roof. These defects were given priorities for repair; within 6 months, between 2-3 years & between 5-10 years. There were also remedial coating works suggested for the roof of the generation building.

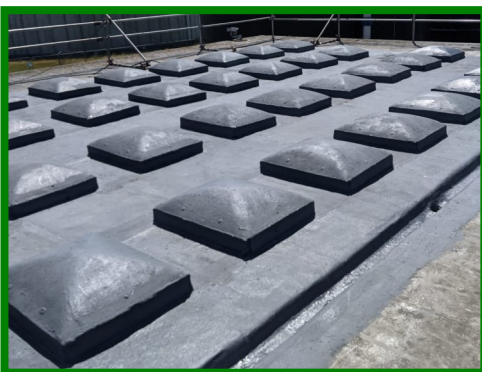
Originally SWCR were to remove the skylight covers and repair the upstands around each skylight. Unfortunately when we removed the first cover it became apparent that the extent of corrosion to the frames was so severe the skylights themselves will need to be replaced as a later project. As the upstands to the skylights were still accessible without removing any covers, it was agreed that we would patch repair around the skylights, concentrating on those within the priority area. The skylights and upstands were cleaned, insulation strips were fitted around the upstand bases. The individual areas were primed and then covered with fibre glass matting. Once the fibre glass was fitting and rolled into the embedment coating, this was also done in-between the skylight and the central drainage channel, this then gave a waterproof seal to this area.
