Premier Inn, Exeter

Concrete Repairs, Waterproof Membrane & Resin Injection,

Project: Premier Inn, Exeter

Main Contractor: Devon Contractors LTD

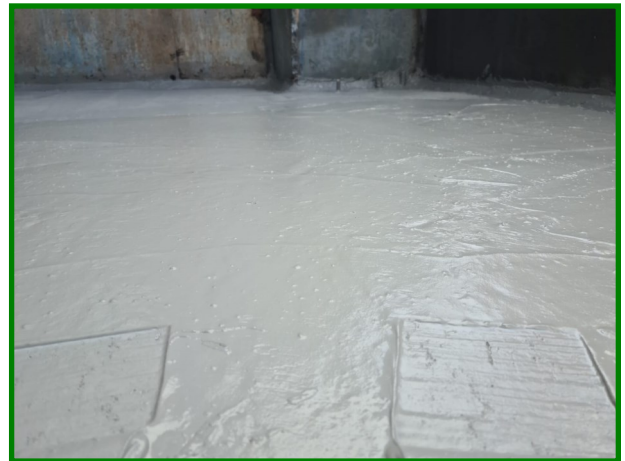
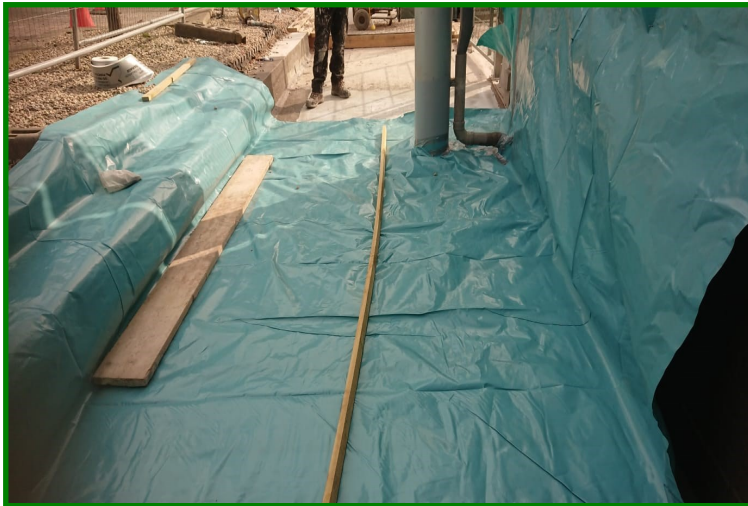
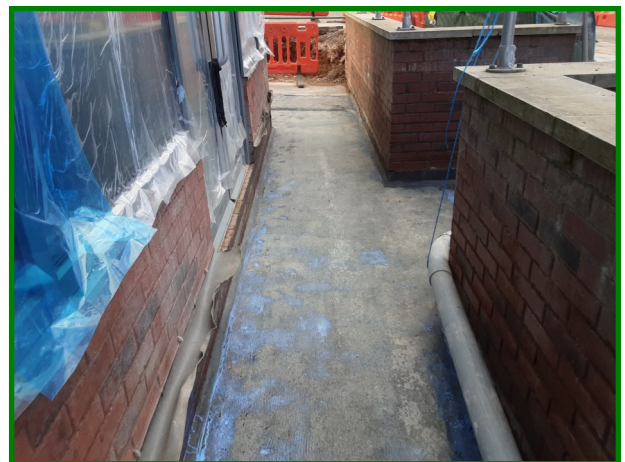
The Problem

The client had reported signs of water ingress at the base of the building going into the building and down into the multi story car park below ground. There was also an issue where the hydrostatic pressure was pushing water up through the base of the car park as the water table in Exeter is higher than the lowest level of the car park.

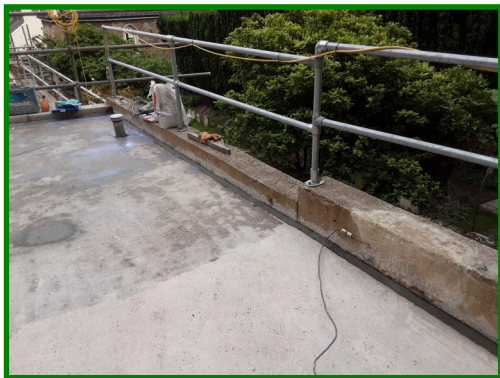
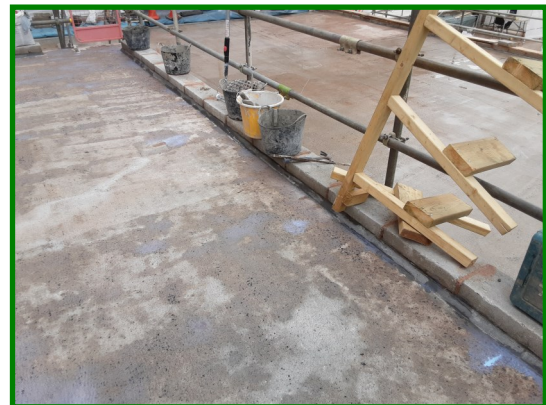
Additional works were required on Phase 4 & 5 before the waterproofing system could be started:

- Isolated areas required Concrete Repairs works. These areas were broken out, cleaned, any steel treated, primed and then repairs in a concrete repair mortar.
- Renewal of Expansion Joints were needed, these were broken out, cleaned and sealed using Sikaflex Pro 3 SL. An Angle fillet was then formed on top.

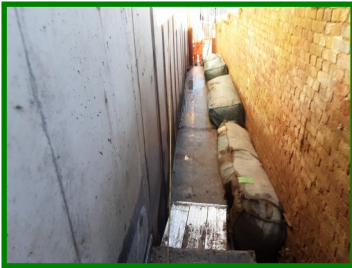
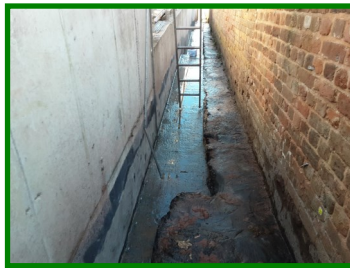
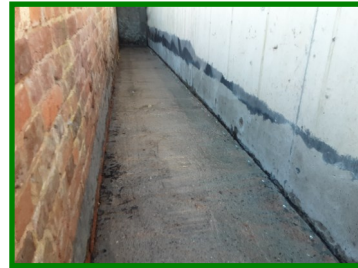
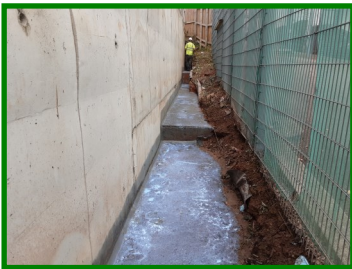
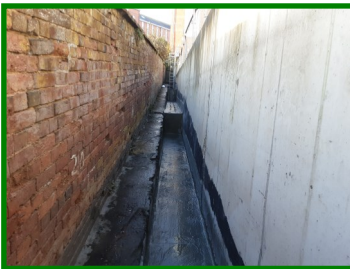
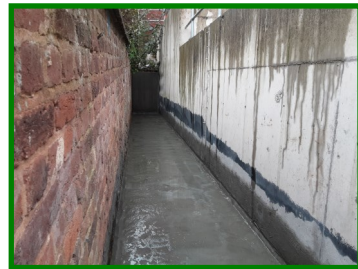
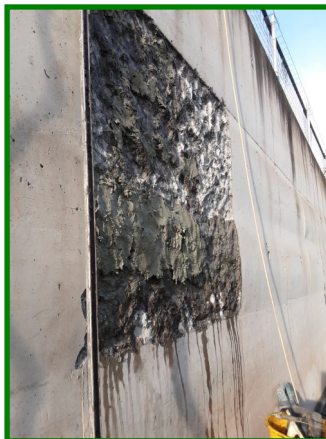
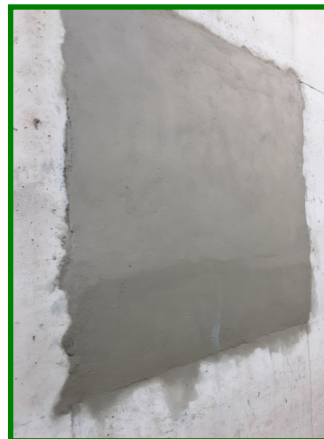
The Solution - Retaining Wall

Works to the retaining wall followed a similar system as the previous phases.

- All surfaces were scabbled to remove all existing coatings and then power washed clean
- Injection nipples were drilled and fixed into place, resin was then pumped in until the cracks were filled.
- A new fall was cast on the existing slab, so that water runs off the slab.
- Isolated areas required patch repairs so that there was a smooth surface for the Cemprotec system.
- Cemprotec EF Primer was the applied to all slab areas prior to the Cemprotec Elastic application to the slab and upstands.
- There was a bulge within the retaining wall, which was broken out, treated where needed and then repairs to a flat finish.
